## REMR TECHNICAL NOTE CS-MR-8.7

### CASE HISTORY OF MONOLITH JOINT REPAIRS: LOCK NO. 2, MISSISSIPPI RIVER

**PURPOSE:** To present a case history of monolith joint repairs in a navigation lock.

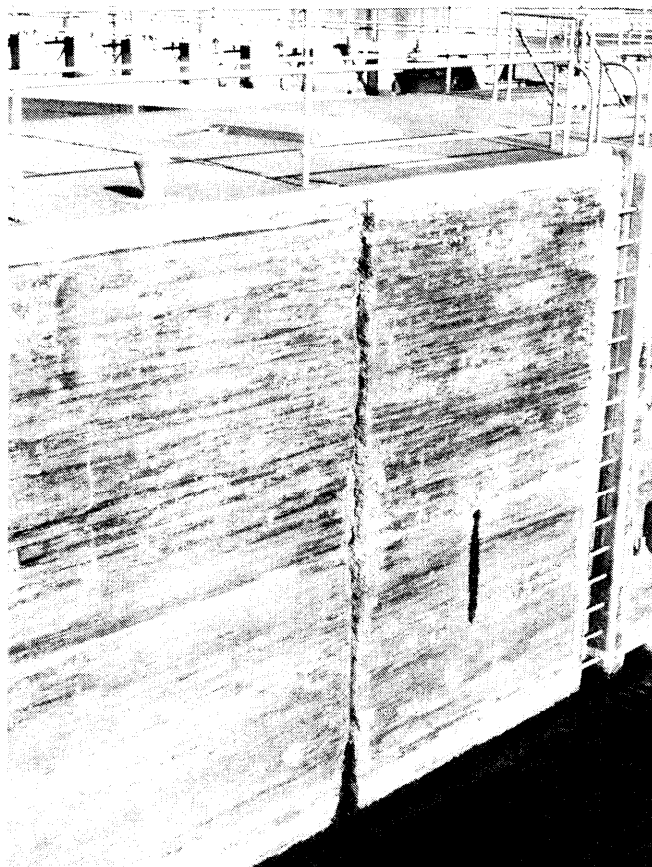
**SPALLING:** In 1985, the only significant concrete deterioration in the landward chamber was spalling at the vertical monolith joints (Ref. a). This spalling was moderate to heavy and extended from approximately 2 ft below the lower pool elevation to the top of the lock wall (Fig. 1). The joints with a southern exposure showed the most deterioration, attributable to an increased number of cycles of freezing and thawing.

Figure 1. Typical monolith joint deterioration

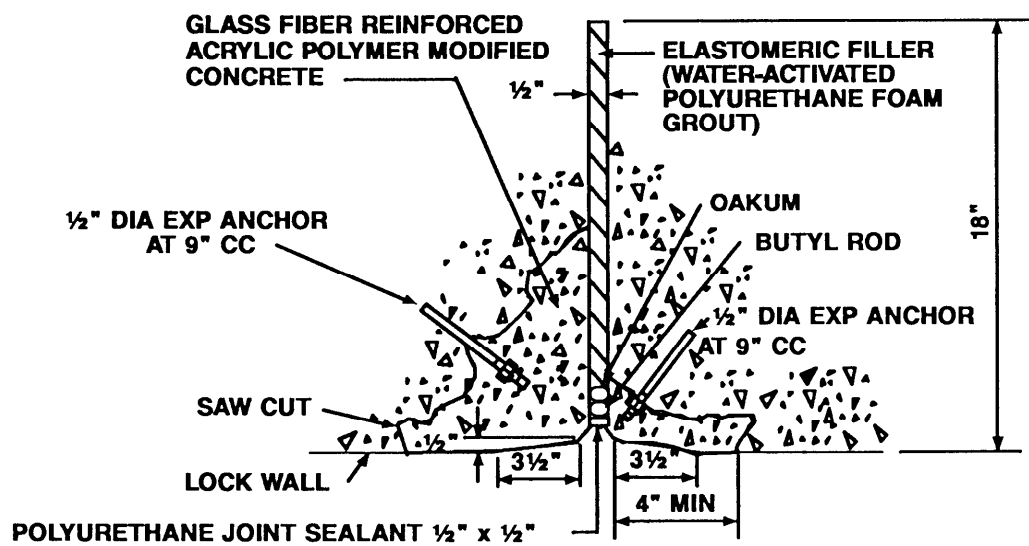
Figure 2. Joint repair detail

The joint was recessed from the face of the lockwall with a bevel 3-1/2 in. by 1/2 in. and a 45 deg chamfer at the joint edge (Fig. 2). The 1/2-in. expansion joint between monoliths was maintained with gatorboard (a styrofoam core with a thin plastic face on both sides). After the FRAPMC had cured sufficiently for the gatorboard to be removed, the soft styrofoam center was removed and the plastic faces previously coated with form oil released easily. The expansion joint was filled with a water-activated polyurethane foam grout and sealed with a polyurethane joint sealant.

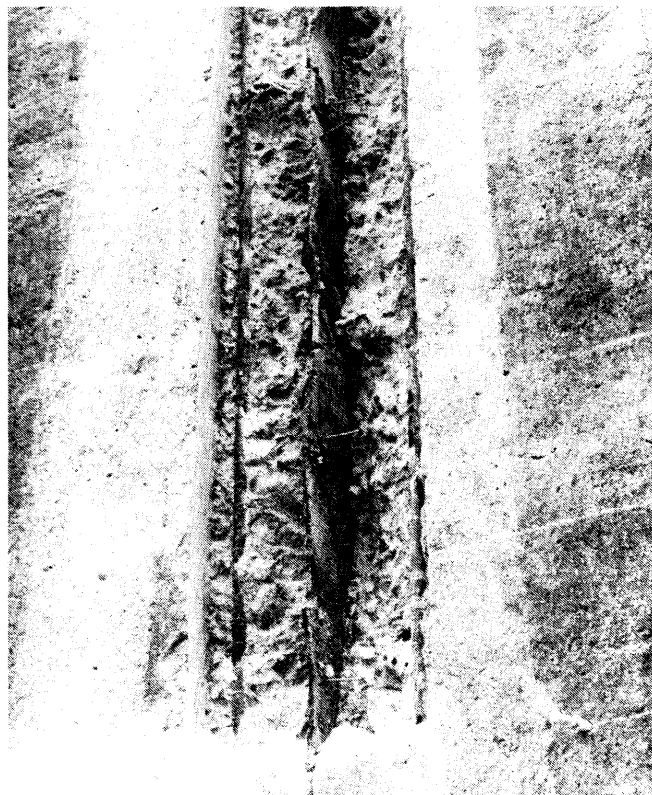
Figure 3. Joint with deteriorated concrete removed

Work began with identification and removal of the deteriorated concrete around the joints. Removal areas were identified by visual examination and with sounding hammers. A 1-1/2-in.-deep saw cut was made around the perimeter of the repair area. The cut was made at a 15-deg angle to form a keyway except for the top joint which was cut perpendicular to the face of the wall. The deteriorated concrete was removed with hand-held jackhammers which allowed the operators to "feel" sound concrete when they reached it. The minimum removal depth was 2 in. (Fig. 3).
